DEPARTMENT OF DEFENCE
DEFENCE SCIENCE AND TECHNOLOGY ORGANISATION
AERONAUTICAL RESEARCH LABORATORY

Technical Report 2

**FIELD EVALUATION OF SIX PROTECTIVE COATINGS APPLIED TO T-56
TUBINE BLADES AFTER 2000 HOURS OF ENGINE USE**

SUMMARY

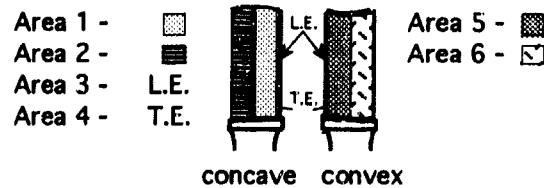
Type of Coating	Area 1	Area 2	Area 3	Area 4	Area 5	Area 6	Ψ
SI ALUMINIDE (1)	1	1	2	1	1	1	1.15
SI ALUMINIDE (2)	1	1	3	1	1	1	1.30
ALUMINIDE B (1) [‡]	2	1	3	1	2	2	1.73
ALUMINIDE A (1)	3	2	2	1	1	1	2.10
CR ALUMINIDE (1)	2	3	3	3	2	1	2.50
PT/RH ALUMINIDE (1) [‡]	3	3	3	3	1	1	2.80
ALUMINIDE B (2)	4	2	4	2	1	2	2.95
CR ALUMINIDE (2)	3	4	4	3	1	1	3.20
PT/RH ALUMINIDE (2)	5	4	2	1	1	1	3.30
PT ALUMINIDE (1)	5	2	4	2	2	1	3.35
PT ALUMINIDE (2)	5	3	4	2	1	1	3.50
ALUMINIDE A (2)	5	3	3	3	2	2	3.60

□ Areas are represented as follows:

□ Numbers under area columns represent relative degrees of attack for that specific area
 (1 - minimal attack 5 - maximum attack)
